# Manhole Inspection Summary

Manhole # S47MM\_029MH

**Location** Address: **Belair Rd**

Cross Street: **Homestead St**

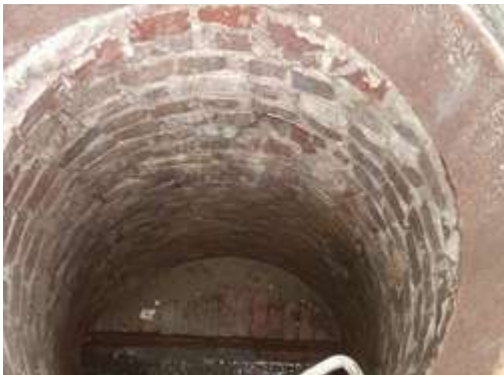
Defect 1

frame leaks

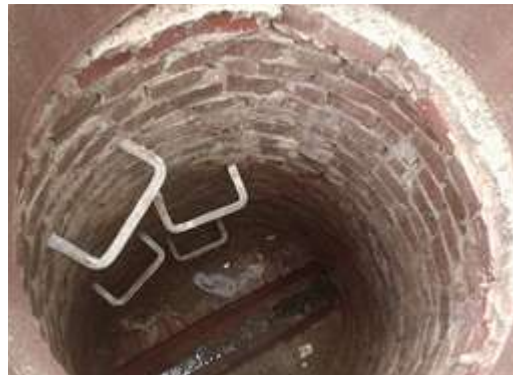
Defect 2

Condition: ☐ Sound ☐ Cracked ☐ Root Intrusion ☒ **Loose Brick** ☐ Deteriorated

Infiltration: ☐ None ☒ **Joint** ☐ Cracks ☒ **Mortar** ☐ Roots ☐ Wall

loose bricks

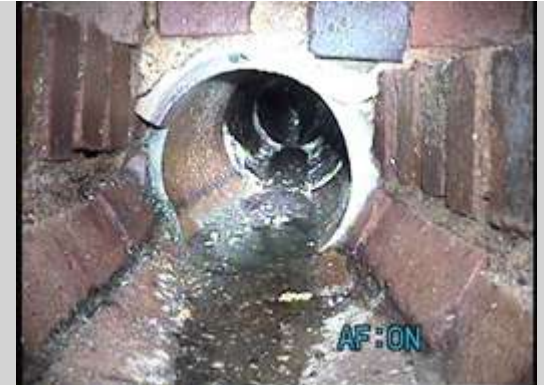
12 O'Clock Outflow

8 in. Circular Gravity Sewer  
Pipe Out @ 12 O'Clock

Pipe Height: **8.4** (in.) Rod and Bar (Angled)  
Pipe Material: **Clay** ☐ Pipe Lined  
Invert Depth: **8.50** (ft.) Flow Characteristics: **None**  
Deposits: ☒ None ☐ Mud ☐ Sludge ☐ Debris ☐ Grease  
Silt Depth: (in.) Deposits Extent:  
Infiltration: **None** Pipe Seal Cond: **Sound**

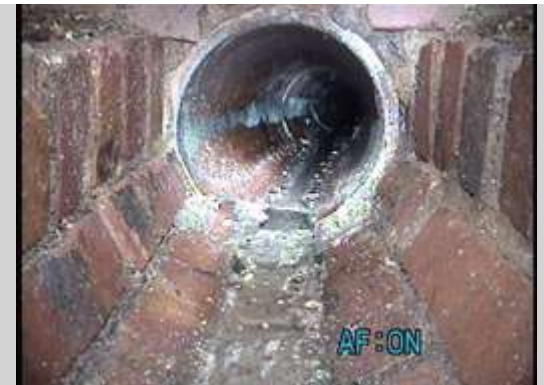
6 O'Clock Inflow

8 in. Circular Gravity Sewer  
Pipe In @ 6 O'Clock

Pipe Height: **8.4** (in.) Rod and Bar (Angled)  
Pipe Material: **Clay** ☐ Pipe Lined  
Invert Depth: **8.25** (ft.) Flow Characteristics: **None**  
Deposits: ☒ None ☐ Mud ☐ Sludge ☐ Debris ☐ Grease  
Silt Depth: (in.) Deposits Extent:  
Infiltration: **None** Pipe Seal Cond: **Sound**
